Critique of :

An Evaluation of Red Shoulders as a Bicycle and Pedestrian Facility

Wayne Pein wpein@nc.rr.com

April 2008

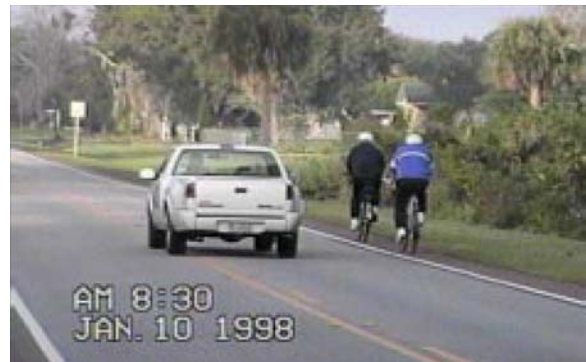
Figure 1. Figure 7 from the report shows a "minor encroachment" over the dashed line.

Analysis: Figures 7, 8, and 9 from the report depict what the author considered minor, moderate, and severe "encroachments" respectively. All of these "encroachments" occurred where the centerline was dashed, formally allowing motorists to fully change lanes, as when passing another motor vehicle. Would a pass of a slower motor vehicle under such conditions be called an "encroachment?"

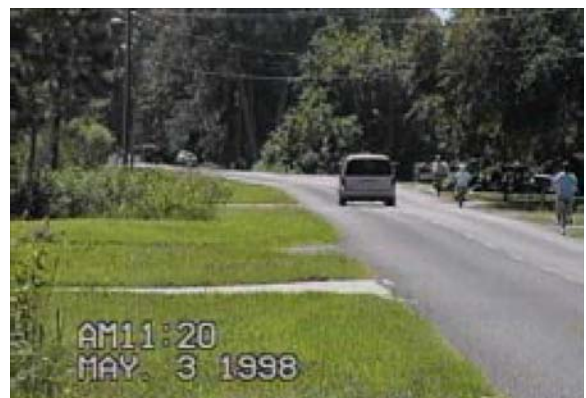
Figure 2. Figure 9 from the report depicts a "severe encroachment" over the dashed line.

The bicyclist's narrow profile, along with typical right-side-of-lane position gives an advantage to the motorist. Thus, partial lane changes, called "straddle passes" are possible and routinely executed when passing bicycle drivers in both passing and no-passing zones. To characterize a partial lane change as an "encroachment" is misleading at best. However, the author rated the maneuver, implying that a "severe encroachment" is worse than a "minor encroachment." An alternative, completely opposite and more accurate view is that a motorist executing a "severe encroachment" is being more considerate by affording greater passing clearance.

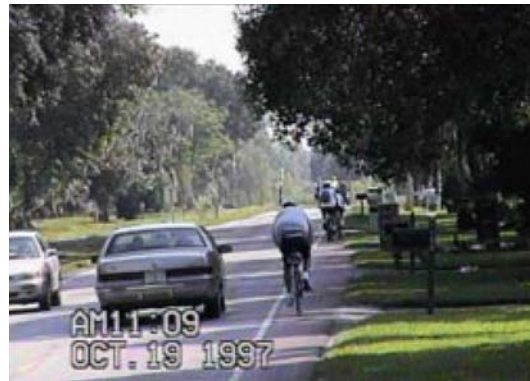
Figure 3. Figure 10 from the report shows passing without "encroachment" of a bicyclist using the left half of the shoulder.

The author believes a pass without "encroachment" is desirable for motor vehicle operation, and wrote, "There were also occasions at this site [red shoulder site 3] where the motor vehicle passed the bicycle without any encroachment into the adjacent traffic lane (Figure 10)." The number or percent of passes without "encroachment" is not given.

An undesirable consequence of not crossing the centerline from such a narrow 9.5-foot lane is very close passing of bicyclists. An 8.5-foot wide truck (not considering extended mirrors) fully left in the lane but not "encroaching" will pass a bicyclist *centered* on the shoulder by a scant 1 foot 3 inches.

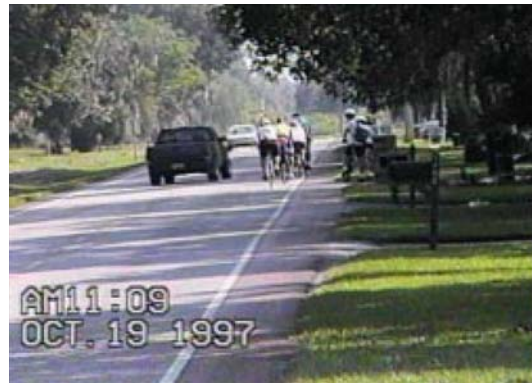
Figure 4. Figure 12 from the report is described as a “potential” bicycle-motor vehicle conflict. Is this classic “Fear From the Rear” mongering?

Analysis: The author again does not define what constitutes a “sudden” change in direction or speed. Figure 12 from the report is called a “potential” bicycle-motor vehicle conflict. From the picture it appears that a group of bicyclists were rightly using the travel lane and a motorist made a straddle pass in a passing permitted zone. Without clearly defined parameters, an alleged sudden change in speed or direction of the motorist may have simply been a figment of the person coding the video.
