# Critique of :

## *An Evaluation of Red Shoulders as a Bicycle and Pedestrian Facility*

Wayne Pein    [wpein@nc.rr.com](mailto:wpein@nc.rr.com)

April 2008

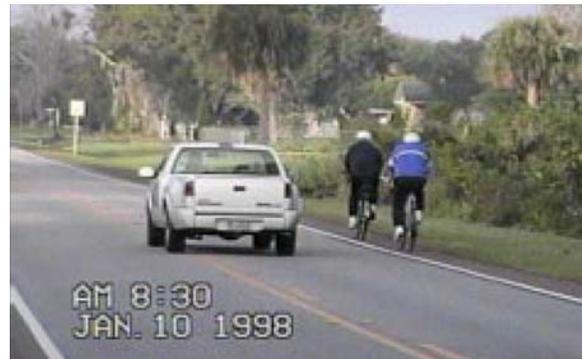
**Figure 1.** Figure 7 from the report shows a "minor encroachment" over the dashed line.

Analysis: Figures 7, 8, and 9 from the report depict what the author considered minor, moderate, and severe "encroachments" respectively. All of these "encroachments" occurred where the centerline was dashed, formally allowing motorists to fully change lanes, as when passing another motor vehicle. Would a pass of a slower motor vehicle under such conditions be called an "encroachment?"

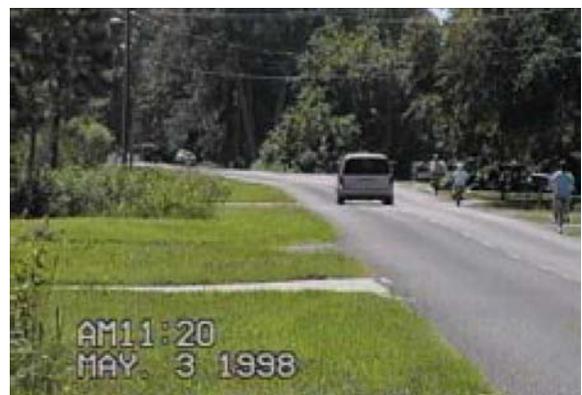
**Figure 2.** Figure 9 from the report depicts a "severe encroachment" over the dashed line.

The bicyclist's narrow profile, along with typical right-side-of-lane position gives an advantage to the motorist. Thus, partial lane changes, called "straddle passes" are possible and routinely executed when passing bicycle drivers in both passing and no-passing zones. To characterize a partial lane change as an "encroachment" is misleading at best. However, the author rated the maneuver, implying that a "severe encroachment" is worse than a "minor encroachment." An alternative, completely opposite and more accurate view is that a motorist executing a "severe encroachment" is being more considerate by affording greater passing clearance.

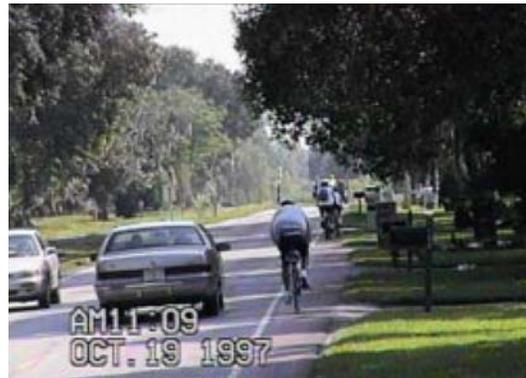
**Figure 3.** Figure 10 from the report shows passing without "encroachment" of a bicyclist using the left half of the shoulder.

The author believes a pass without "encroachment" is desirable for motor vehicle operation, and wrote, "There were also occasions at this site [red shoulder site 3] where the motor vehicle passed the bicycle without any encroachment into the adjacent traffic lane (Figure 10)." The number or percent of passes without "encroachment" is not given.

An undesirable consequence of not crossing the centerline from such a narrow 9.5-foot lane is very close passing of bicyclists. An 8.5-foot wide truck (not considering extended mirrors) fully left in the lane but not "encroaching" will pass a bicyclist *centered* on the shoulder by a scant 1 foot 3 inches.

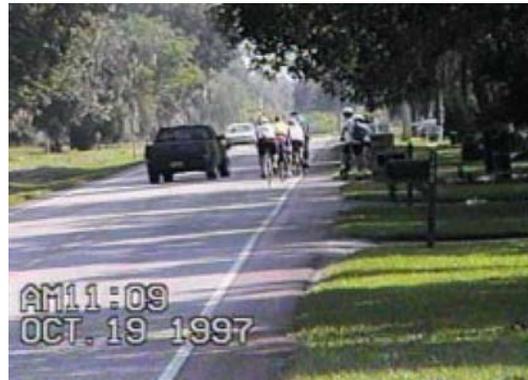
**Figure 4.** Figure 12 from the report is described as a “potential” bicycle-motor vehicle conflict. Is this classic “Fear From the Rear” mongering?

Analysis: The author again does not define what constitutes a “sudden” change in direction or speed. Figure 12 from the report is called a “potential” bicycle-motor vehicle conflict. From the picture it appears that a group of bicyclists were rightly using the travel lane and a motorist made a straddle pass in a passing permitted zone. Without clearly defined parameters, an alleged sudden change in speed or direction of the motorist may have simply been a figment of the person coding the video.
